SAIB: CE-18-26

Date: September 4, 2018

SUBJ: Liquid Penetrant Inspection; Using Visible Dye Penetrant

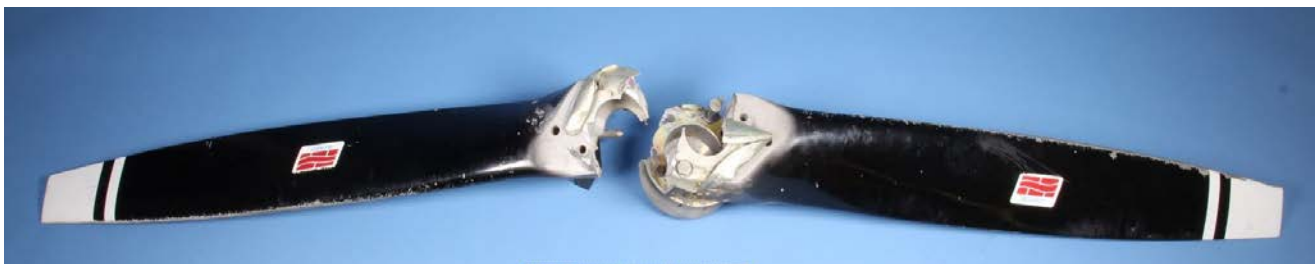
The picture below captures a propeller from an accident. As can be seen, the accident propeller was a single-piece, aluminum, fixed-pitched model. Although the airplane was destroyed, the two occupants survived with serious injuries.

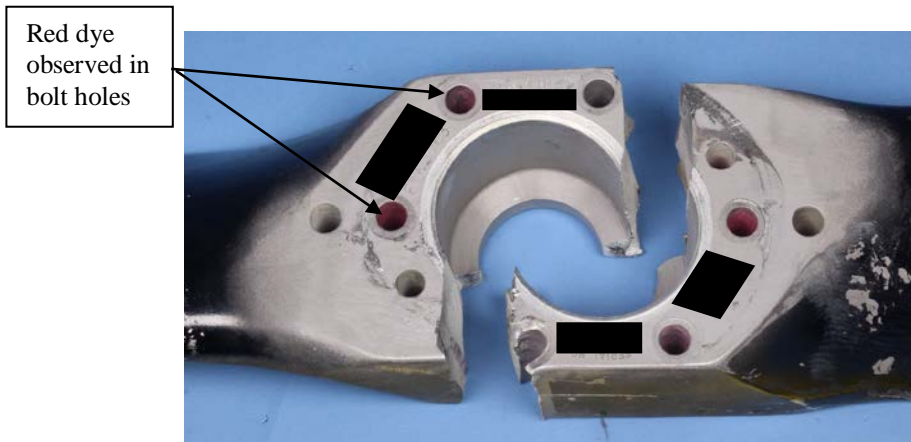
In the photograph above, you can observe residual visible red dye penetrant in some of the propeller hub holes from a prior inspection. It was concluded that post inspection cleaning after the use of red dye was not adequate and did not remove all of the red dye material. Fluorescent dye penetrant was used for the last AD inspection just prior to the propeller failure. Fluorescent penetrant inspection loses effectiveness when there is improper cleaning of red dye from a previous inspection. Visible dye material residue can be extremely difficult to remove and can fill voids, flaws, and cracks, which can affect subsequent inspections. Visible dye residue contamination of fluorescent penetrant fluid is also known to significantly reduce the brightness of fluorescent indication and can mask the fluorescent agent, causing flaws in the part to be minimized or missed at the next inspection.

Due to these characteristics, visible dye penetrants can make existing cracks nearly impossible to detect when using fluorescent penetrant inspection for the next inspection. Pre- and post-inspection cleaning is critical to ensure the ability to detect cracks during current and follow-on inspections and is essential to ensure proper detection of the anomalies and cracks in the article. Inspection material residuals can also lead to corrosion.

- Adhere to the prohibition contained in American Society for Testing and Materials (ASTM E 1471), which prohibits the use of Type II visible dye penetrant prior to the use of Type I fluorescent penetrants for the same surface.

- Adhere to the DAH pre- and post-inspection cleaning methods and materials to ensure any residual developer, penetrant, and/or visible dye residues are removed which could affect subsequent inspections.
